# 换热器 T2 紫铜管在水线部位的腐蚀机理研究

李超, 王长罡, 董俊华\*

## Corrosion Mechanism of T2 Copper Tube at Water Line Positions

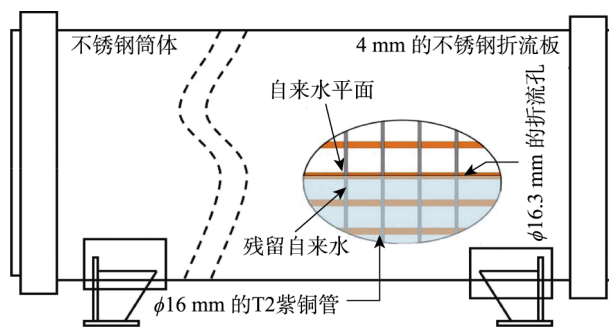
最近,在某换热器中发现 T2 紫铜管出现了点蚀穿孔失效现象。该换热器结构如图 1 所示,壳体为 304 不锈钢筒体结构,内部由直径  $\phi 16\text{ mm}$ 、壁厚 1.1 mm 的 T2 紫铜冷凝管和厚度为 4 mm 的 304 不锈钢折流板构成。304 不锈钢折流板上开有  $\phi 16.3\text{ mm}$  的折流孔,这些折流孔的作用是在换热器筒体内固定 T2 紫铜管。换热器工作时,水循环在筒体内,氟利昂在 T2 紫铜管内循环。由于设备调试用水未排尽,残留在筒体底部的水与 T2 紫铜管接触,导致腐蚀穿孔的发生。这一现象表明,水线部位的腐蚀环境对 T2 紫铜管具有显著的腐蚀作用。本工作研究分析了 T2 紫铜管在该环境中保存 2 a 后的腐蚀特征及机理,可以更好地理解铜管腐蚀的本质,为预防和控制铜管腐蚀提供了理论依据和实践指导。未来的研究可以进一步探索不同环境因素对铜管腐蚀的影响,以及开发新型的防腐措施和技术,以提高铜管的服役寿命。

图1 T2 紫铜管与不锈钢折流板结构  
Fig.1 Schematic structure of T2 copper tube and stainless steel baffle

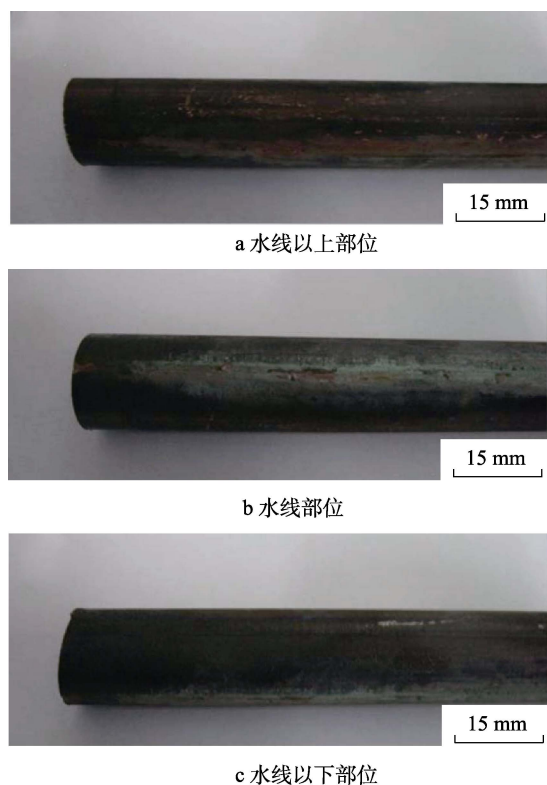
图 2 所示。由图 2 可知, 铜管水线以上部位主要呈均匀腐蚀的特征 (见图 2a), 整个铜管被腐蚀产物所覆盖, 腐蚀产物的颜色为内层砖红色和外层黑色。在铜管水线部位, 则以点蚀为主 (见图 2b), 用肉眼即可观察到排成直线的斑点状腐蚀坑, 腐蚀产物的颜色主要为黑色和绿色。铜管水线以下部位的腐蚀情况与水线以上部位相似, 同样以均匀腐蚀为主, 整个铜管被腐蚀产物所覆盖, 但腐蚀产物的颜色为黑色和绿色 (见图 2c)。

图 2 铜管的宏观形貌

- a) above the waterline position; b) at the waterline position;  
c) below the waterline position

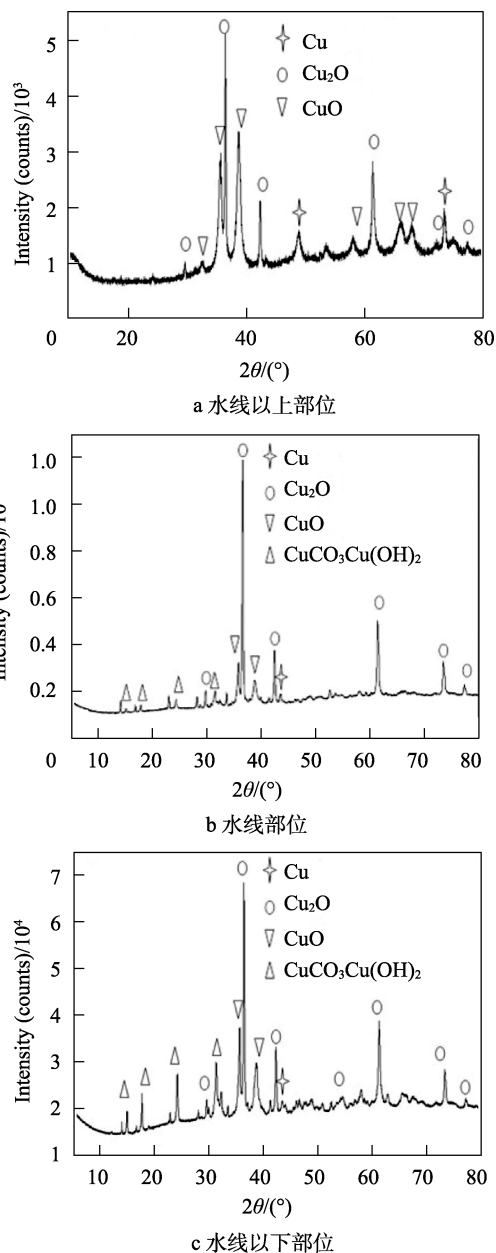
T2 紫铜管受腐蚀后, 不同部位腐蚀产物的 XRD 分析结果如图 3 所示。结果表明, 水线以上部位的主要腐蚀产物为  $\text{Cu}_2\text{O}$  和  $\text{CuO}$ , 这 2 种氧化物在铜的腐蚀过程中扮演了关键角色。水线处的主要腐蚀产物除了有  $\text{Cu}_2\text{O}$  和  $\text{CuO}$  以外, 还检测到了  $\text{CuCO}_3\text{Cu}(\text{OH})_2$ 。同样地, 水线以下部位的主要腐蚀产物也包含了  $\text{Cu}_2\text{O}$ 、 $\text{CuO}$  和  $\text{CuCO}_3\text{Cu}(\text{OH})_2$ 。从腐蚀机理的角度分析, 无论是水线上部、水线部位还是水线下部, 腐蚀过程都遵循一定的规律。在腐蚀初期, 铜管表面首先形成  $\text{Cu}_2\text{O}$ , 而后部分  $\text{Cu}_2\text{O}$  在湿条件下被进一步氧化为  $\text{CuO}$ 。此外, 空气中的  $\text{CO}_2$  溶解于水中, 形成  $\text{HCO}_3^-/\text{CO}_3^{2-}$ ,  $\text{HCO}_3^-$  与水线部位和水线以下的 T2 紫铜管内层腐蚀产物  $\text{Cu}_2\text{O}$  继续反应, 使之转变成附着

图 3 铜管腐蚀产物的 XRD 分析结果

- a) above the waterline position; b) at the waterline position;  
c) below the waterline position

于铜管外表面的  $\text{CuCO}_3\text{Cu}(\text{OH})_2$ , 进一步改变了腐蚀产物的成分和分布。

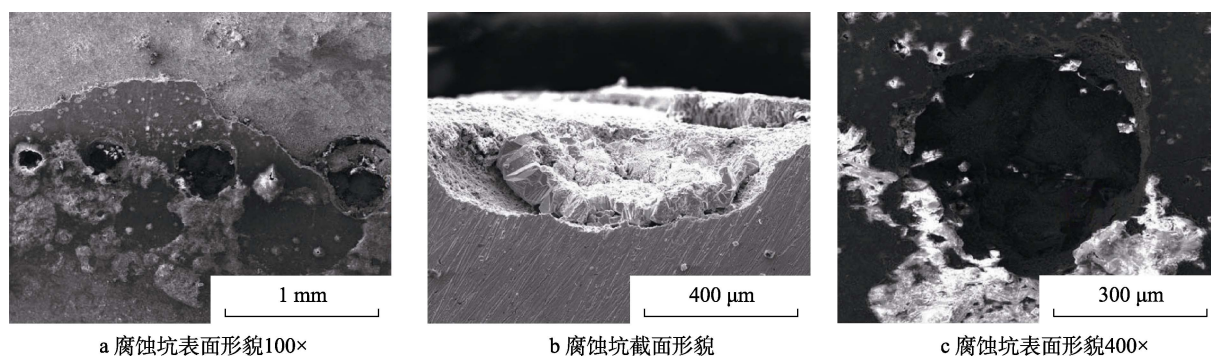
为了更深入地了解腐蚀过程, 对水线部位 T2 紫铜管腐蚀坑的微观表面形貌进行了观察和分析, 如图 4a 所示。可以看出, T2 紫铜管水线部位的腐蚀坑沿着水线规则地平行分布, 腐蚀坑呈圆形, 直径为  $100\sim 400\ \mu\text{m}$ 。这些腐蚀坑裸露于外, 表面没有腐蚀产物覆盖。试样上半部腐蚀产物部分脱落, 这可能与取样操作有关。T2 紫铜管水线部位某点蚀坑的截面显微形貌如图 4b 所示。该腐蚀坑直径为  $1\ \text{mm}$

左右,且腐蚀坑的深度可达 300  $\mu\text{m}$  左右。由腐蚀坑截面形貌可以看出,腐蚀坑内部的腐蚀产物有数十微米厚。表面某腐蚀坑 400 $\times$ 的放大形貌如图 4c 所示,该腐蚀坑呈圆形,直径约为 400  $\mu\text{m}$ 。通过该腐蚀坑内部的 EDS 分析结果(见表 2)可知,腐蚀坑内主要的腐蚀产物为铜的氧化物。同时,腐蚀产物中 C 元素的比例较高,说明腐蚀产物中含有一定量

图 4 扫描电子显微镜下观察到的水线部位点蚀坑形貌

Fig.4 Microstructures of copper tube pitting corrosion at the waterline position: a) surface morphology of pitting 100 $\times$ ; b) cross-sectional morphology of pitting; c) surface morphology of pitting 400 $\times$

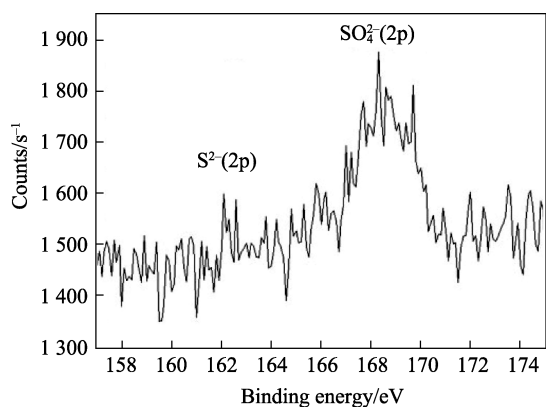
的  $\text{HCO}_3^-$ 。腐蚀产物中的 S 元素应来源于水环境,为了确定 S 元素是以  $\text{SO}_4^{2-}$  还是  $\text{S}^{2-}$  形式存在,对样品进行 XPS 分析。XPS 结果(如图 5 所示)表明,腐蚀产物中 S 元素 2p 轨道的结合能位于 168~170 eV,该结合能为  $\text{SO}_4^{2-}$  的特征结合能,说明腐蚀产物中的 S 元素以  $\text{SO}_4^{2-}$  形式存在,表明进入冷凝器的水中含有  $\text{SO}_4^{2-}$ 。

图 5 T2 紫铜管水线部位腐蚀产物中硫元素价态的 XPS 分析

Fig.5 XPS result of sulfide valence of corrosion products at the waterline position of copper tube

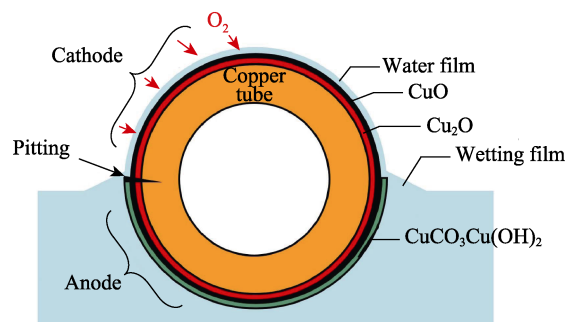
管腐蚀机理模型如图 6 所示。当换热器处于有残留水存在的静止保养状态时,换热器内环境的相对湿度较高。受环境温度周期性升高或降低的影响,湿度较高的水蒸气可在水线上部的 T2 紫铜管表面结露形成薄液膜。在水线处,水与 T2 紫铜管表面接触,因表面张力发生润湿,形成有一定厚度的润湿薄液膜。该润湿薄液膜与水线以上铜管薄液膜相互连接,形成连续的电解液环境,为 T2 紫铜管发生电化学腐蚀提供了必要条件。水线以上铜管表面的薄液膜与空气充分接触,在该薄液膜内的氧扩散十分充足,该部位 T2 紫铜管表面氧含量较高。在水线以下部位,水以连续介质状态与 T2 紫铜管接触,虽然溶解氧也能接触到管壁,但对比水线以上部位的供氧情况,其水平相对较低。因此,水线以上与水线以下的 T2 紫铜管之间形成了氧浓差电池,水线以上铜管为阴极,水线以下铜管为阳极,阴阳两极在水线部位交汇。通常在电偶腐蚀中,阴阳极交汇位置的腐蚀最为严重<sup>[25]</sup>,因此该水

图 6 水线部位铜管腐蚀失效机理模型

Fig.6 Schematic corrosion failure mechanism model for copper tube at the waterline position

线位置正好成为铜管腐蚀最严重的部位。
