# 堆芯中子通量测量系统指套管磨损分布规律 及处理准则优化研究

**摘要:** **目的** 分析堆芯中子通量测量系统指套管磨损分布规律, 提出处理准则优化建议。**方法** 统计了指套管在堆芯不同位置的磨损数量, 分析了指套管磨损分布规律。结合指套管和导向管的结构特点和视频检查结果, 分析了指套管的磨损原因, 并提出了指套管磨损处理准则优化建议。**结果** 指套管磨损位置主要集中在P1和P4两处, 其中P1位置磨损数量最多, 而P2、P3和P5位置磨损数量较少。P1和P4两处的指套管磨损形貌差异较大, 在P1位置, 由于指套管易发生方向随机的高频低振幅微动磨损行为, 导致产生较窄的环槽形缺陷; 在P4位置, 指套管则易发生低频高振幅的微动磨损行为, 导致产生较宽的楔形缺陷。**结论** 指套管和导向管的结构特性、冷却剂流场等因素均对指套管磨损有较大影响, 不同位置处指套管磨损缺陷形貌差异较大。有必要分别建立针对P1位置和P4位置的指套管磨损处理准则, 使得核电厂对于指套管的磨损处理更有针对性, 以有效延长指套管的服役寿命。

## Research on Wear Distribution and Wear Acceptance Criteria Optimization of In-core Neutron Flux Instrumentation System Thimble Tube

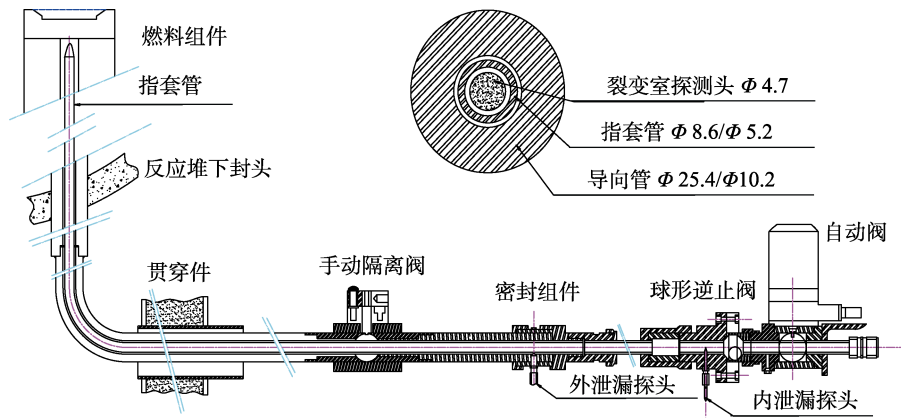
构将微型裂变室从起点沿置于导向管内的指套管插入堆芯顶部,再均匀下降,与此同时,通量测量电路测出微型裂变室的输出电流。当微型裂变室达到堆芯底部时,测量停止。此时驱动机构再将微型裂变室抽回起点,接着将微型裂变室再插入第2个通道进行测量,直至全部测完该组10个通道为止。堆芯中子通量测量系统共有50根指套管,其长度为13~17 m不等。指套管外径为 $\Phi 8.6$  mm,内径为 $\Phi 5.2$  mm,最小壁厚为1.65 mm,材料为Z5CND17-12(加工硬化)。指套管导向通道布置如图1所示,核反应堆装料后,指套管依次经过自动阀、逆止阀、密封组件、手动阀、贯穿件后,沿导向通道进入反应堆压力容器。导向通道自下而上依次为堆芯中子通量测量导向管、反应堆压力容器导向管、堆内构件支撑柱组件导向管、燃料组件仪表导向管,如图2所示。

图 1 指套管导向通道布置  
Fig.1 Arrangement of thimble tube guide card

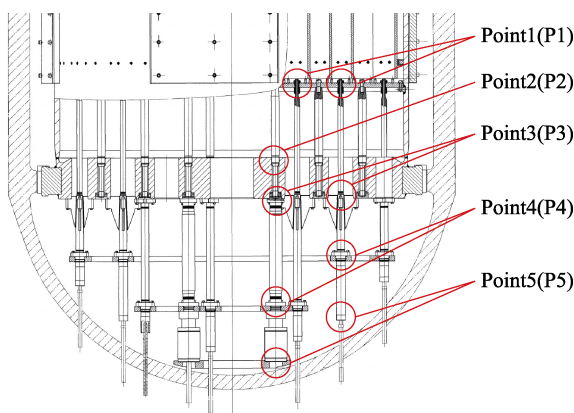
图 2 指套管磨损位置分布  
Fig.2 Distribution of thimble tube wear

某核电站某机组指套管磨损分布 3D 散点图如图 3 所示，表明了指套管磨损位置在三维空间的分布。三维坐标代表磨损位置，Z 轴自上而下依次代表 P1—P5 的 5 个磨损位置，如图 2 所示。P1 为下堆芯板上表面位置，P2 为堆芯支撑板上表面位置，P3 为堆芯支撑板下表面位置，P4 为堆芯支撑柱与格架板连接处，P5 为堆芯支撑柱与反应堆压力容器测量管座连接处；X 轴和 Y 轴代表指套管对应的堆芯位置编码；散点颜色代表磨损深度。可以看出，指套管磨损发生在导向通道内径改变处<sup>[1]</sup>，主要集中在 P1 和 P4 两处，其中 P1 位置磨损数量最多，P4 位置磨损次数次之，P2、P3 和 P5 位置磨损数量较少。国内数十台机组百余次大修指套管 P1—P5 位置磨损涡流检

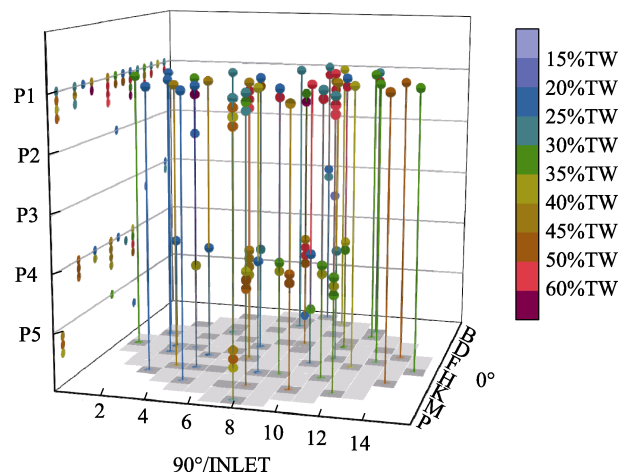
查次数统计结果见表 1<sup>[18-19]</sup>，进一步验证了上述结论。进一步观察发现，磨损位置对应的堆芯坐标分散，散点颜色在堆芯位置内随机分布，说明磨损位置和深度在指套管堆芯位置上无明显分布规律。

图 3 某机组指套管磨损分布 3D 散点图  
Fig.3 3D scatterplot of thimble tube wear distribution of a unit

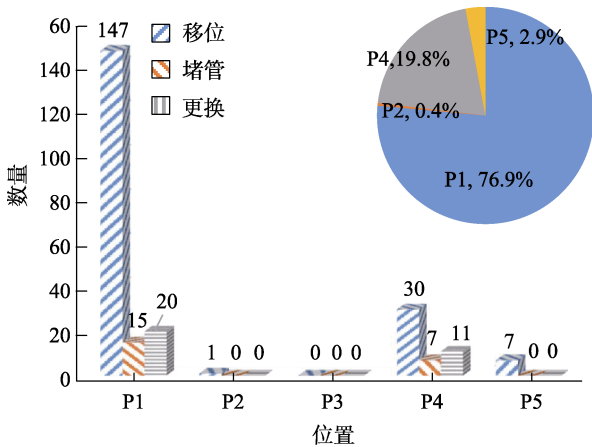
相较于磨损次数，因磨损导致的指套管维修次数更能反映出指套管磨损对于核电站运维的影响，此处维修是指指套管割管移位、堵管或更换等大修期间执行的维修活动。国内某些机组共 123 次大修中实施指套管维修的次数统计如图 4 所示，共计 238 次，主要集中在 P1 位置，占比高达 76.9%，P4 位置次之，占

比为 19.8%，P2、P3 和 P5 位置维修次数较少，合计占比仅为 3.3%。

图 4 国内机组指套管维修次数  
Fig.4 Repair times of thimble tube of China NPPs

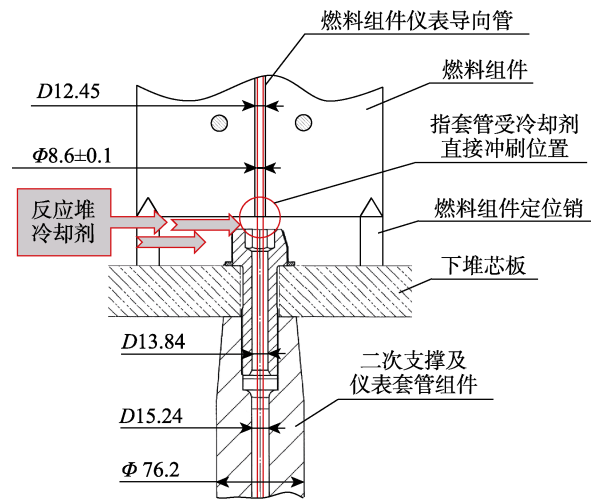
指套管经过 P1 位置示意如图 5 所示，P1 位置位于下堆芯板上表面，为燃料组件支撑板指套管出口处。该位置有部分指套管暴露在反应堆冷却剂中（见图 5 中圆圈位置处），将直接受到反应堆冷却剂强烈的垂直于轴向的横向流冲刷作用。燃料组件仪表导向管的内径为 12.45 mm，略小于二次支撑及仪表套管组件在靠近冲刷位置的内径 13.84 mm，即该位置导向通道存在变径。指套管与燃料组件仪表导向管的单边缝隙仅为 1.93 mm，小于其与二次支撑及仪表套管组件在靠近冲刷位置的单边间隙 2.62 mm。因此，磨损位置理论上应靠近燃料组件仪表导向管出口处。由于冷却剂的冲刷方向垂直于指套管轴向，且指套管受冲刷面积较小，因此指套管在此处发生方向随机的高频低幅振动，与燃料组件仪表导向管内壁发生摩擦磨损。典型的 P1 位置处指套管磨损视频检查结果见图 6，呈现出宽度约几毫米的环槽形磨损特征。

图 5 指套管经过 P1 位置示意  
Fig.5 Darwing of thimble tube at Point 1

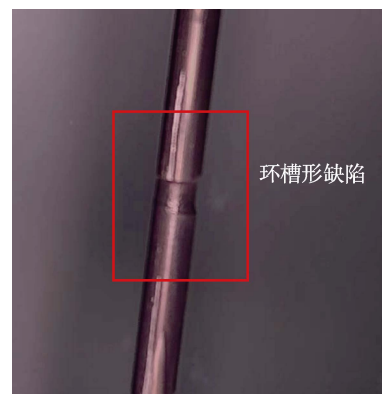
图 6 指套管在 P1 位置的磨损形貌  
Fig.6 Wear profile of thimble tube at Point 1

目前采用的磨损处理准则只将磨损深度作为依据，尚未将磨损缺陷宽度考虑在内，也没有区分磨损位置。文中通过分析磨损分布规律和磨损形貌发现，P1 位置和 P4 位置指套管磨损最为严重，且磨痕的几何形态存在显著差别，分别为几毫米宽的环槽形磨痕和数十毫米宽的楔形磨痕。目前业界已开展了针对指套管磨损缺陷长度分析的相关研究工作<sup>[22-25]</sup>，初步具备了针对两类磨损缺陷分别建立相应处理准则的基本条件，后续有必要进一步开展深入的研究，建立区分 P1 位置和 P4 位置的磨损处理准则，使指套管的磨损维修处理更有针对性，保证指套管服役安全，并延长指套管的服役寿命，提高电厂运行的经济性。

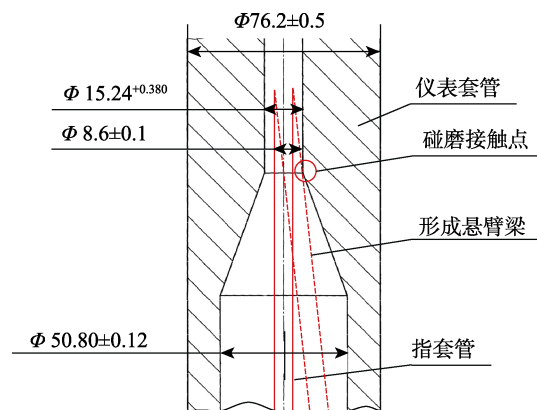
指套管经过 P4 位置示意图见图 7，P4 位置位于堆芯支撑柱与格架板连接处，为二次支撑柱指套管入口处节点。该位置呈现明显的变径特征，指套管在此处通过时，形成悬臂梁结构，容易在流体扰动作用下与导向通道发生碰磨。同时，该处几何结构类似于喷嘴，根据流体力学节流原理，冷却剂流经此处时流速变化快，流场变化复杂，加剧了指套管流体诱发振动的现象。与 P1 位置不同，P4 位置的冷却剂冲刷方向并非垂直于指套管的轴向，而是与指套管轴向形成较小的角度（ $< 45^\circ$ ），且指套管受冲刷的面积较大，因

此产生的冲刷应力在理论上较 P1 位置小。由于 P4 位置导向管内径（15.24~50.80 mm）显著大于 P1 位置的导向管内径（12.45 mm），因此，指套管有更大的变形空间，易发生低频高振幅的振动，导致指套管在较长轴向长度范围内发生磨损。典型的 P4 位置处指套管磨损视频检查结果如图 8 所示，呈现出宽度约数十毫米的楔形磨痕特征，磨痕宽度显著大于 P1 位置。

图 7 指套管经过 P4 位置示意  
Fig.7 Darwing of thimble tube at Point 4

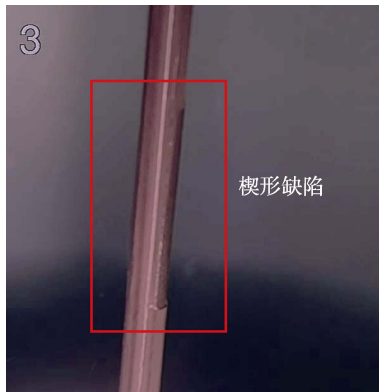
图 8 指套管在 P4 位置的磨损形貌  
Fig.8 Wear profile of thimble tube at Point 4
